# MASTIC MORICHES SHIRLEY COMMUNITY LIBRARY

## BUILDING CONDITION REVIEW REPORT

JULY 2, 2010

SANDPEBBLE BUILDERS INC.  
921 COUNTY ROAD 39  
SOUTHAMPTON, NY 11968  
631-287-6000

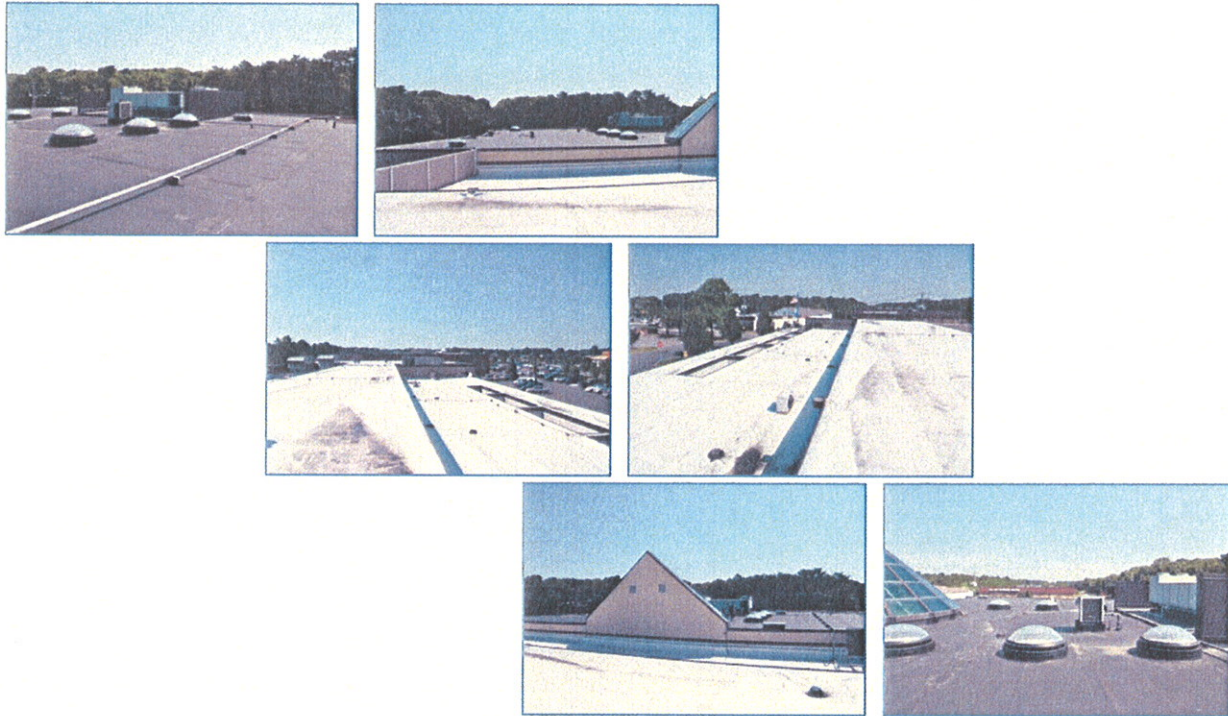
MANY OF THE CEILINGS AND WALLS SHOW EVIDENCE OF LEAKS. IN 2009, THE 1982 SECTION WAS REROOFED AND THE SEAMS AND INTERSECTIONS ON THE ROOF ON THE 1995 AREA WERE REDONE. ACCORDING TO FEEDBACK FROM SOME OF THE MAINTENANCE PERSONNEL, THIS HAS ELIMINATED THE ROOF LEAK PROBLEM AT THIS TIME. THE ONLY EXCEPTION SEEMS TO BE SOME LEAKAGE AT THE ROOF TOP AIR CONDITIONING UNITS DURING A WIND DRIVEN RAIN.

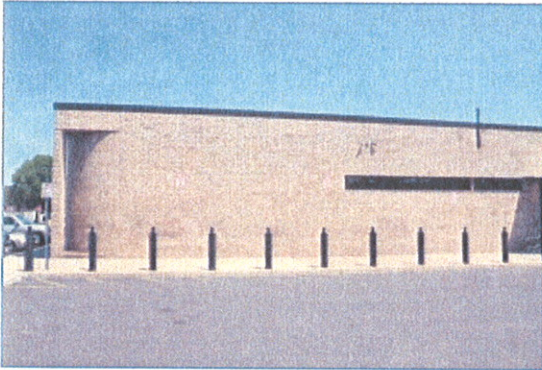
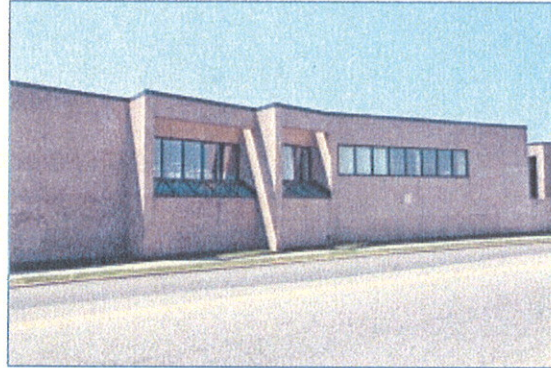
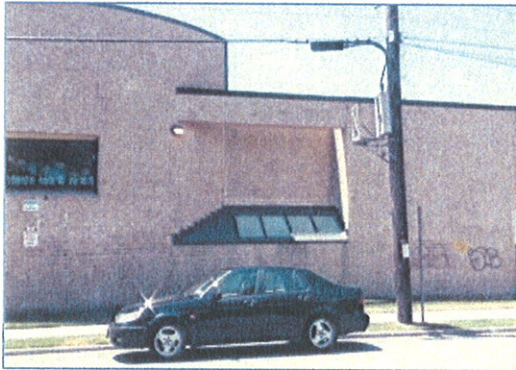
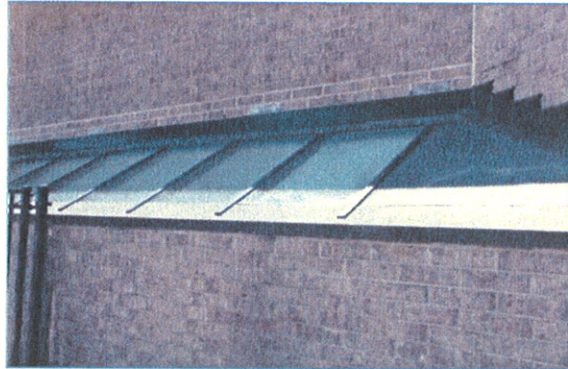
THE GENERAL CONDITION OF THE BRICK APPEARS TO BE GOOD WITH LITTLE OR NO MORTAR JOINT FAILURE. THERE WAS EVIDENCE OF MANY FLASHING FAILURES AT THE INTERSECTIONS OF THE BRICK WITH SKYLIGHT FRAMES AND OTHER PENETRATIONS. THERE WERE STAINED CEILING TILES BELOW SOME OF THESE AREAS AND IT WAS NOT CLEAR WHETHER REPAIRS MADE IN THESE AREAS WERE TOTALLY WEATHER TIGHT. CHANGING THESE TILES WOULD HELP DETERMINE THIS.

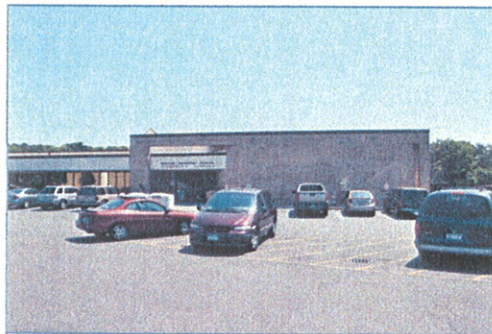
A PATCH AT THE FRONT FACADE WAS MADE WITH BRICKS OF A DIFFERENT COLOR. BRICKS ARE AVAILABLE IN A COLOR MORE CLOSELY MATCHING THE ORIGINAL BRICK.

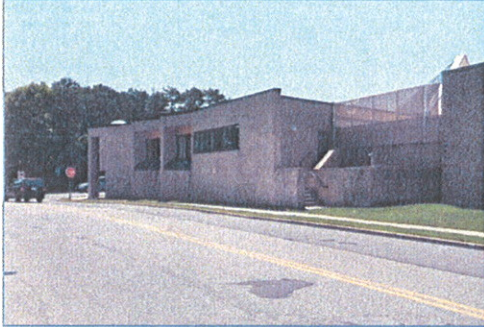
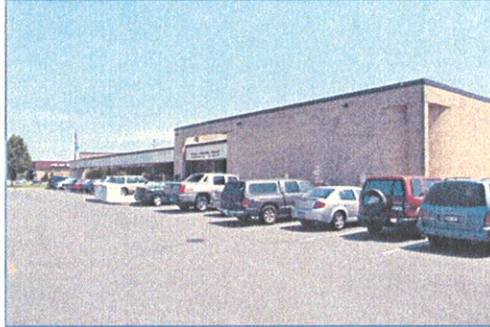
THE ENTIRE BRICK FAÇADE WOULD BENEFIT FROM A THOROUGH CLEANING.

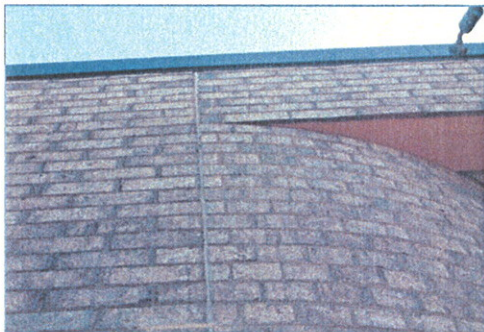
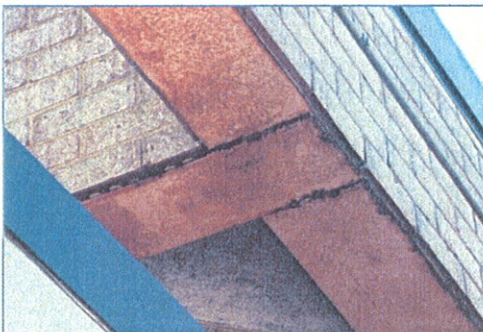
STEEL SUPPORT LINTELS IN THE BRICKWORK ARE SHOWING SIGNS OF  
CORROSION

THE PAINTED STEEL LINTELS SUPPORTING THE BRICK AT VARIOUS OPENINGS AROUND THE BUILDING ARE RUSTING, AND THEIR EXPOSED AREAS SHOULD BE PREPARED AND PAINTED. SINCE THE LINTELS DID NOT RECEIVE A GALVANIZED COATING PRIOR TO INSTALLATION, THOSE PORTIONS IN CONTACT WITH THE MASONRY AND HIDDEN FROM VIEW WILL CONTINUE TO DEGRADE OVER TIME, BUT THE PAINT WORK WILL HELP TO SLOW THE CORROSION RATE FOR THE EXPOSED SURFACES.

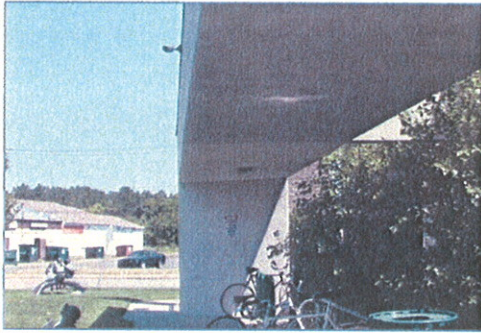
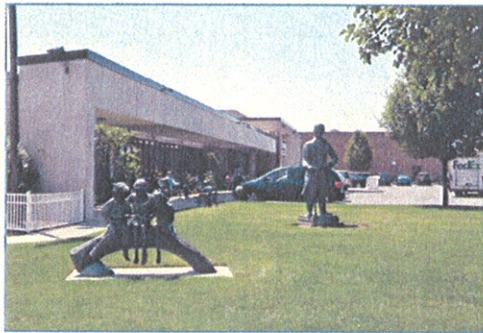
IN SOME AREAS, THESE ARE BADLY SOILED AND WOULD BENEFIT FROM CLEANING AND PAINTING.

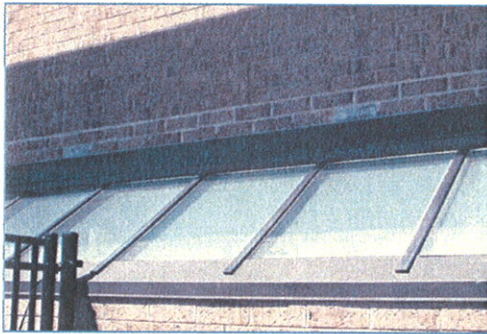
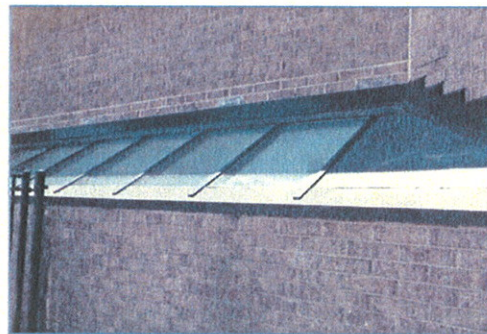
SOME INSULATED GLASS PANELS HAVE FOGGED UP AND NEED REPLACEMENT

WINDOW ASSEMBLIES CONSIST OF DOUBLE PANED INSULATING GLASS SET IN BRONZE ALUMINUM FRAMES. MINIMAL EVIDENCE OF LEAKS WAS OBSERVED. AS INSULATED GLASS PANELS AGE, THE PERIMETER SEAL BETWEEN THE PANES FAIL AND THE INFILTRATION OF MOISTURE CAUSES THE PANEL TO "FOG UP". THIS CONDITION WAS NOTICED AT SEVERAL LOCATIONS AND THESE UNITS SHOULD BE REPLACED.

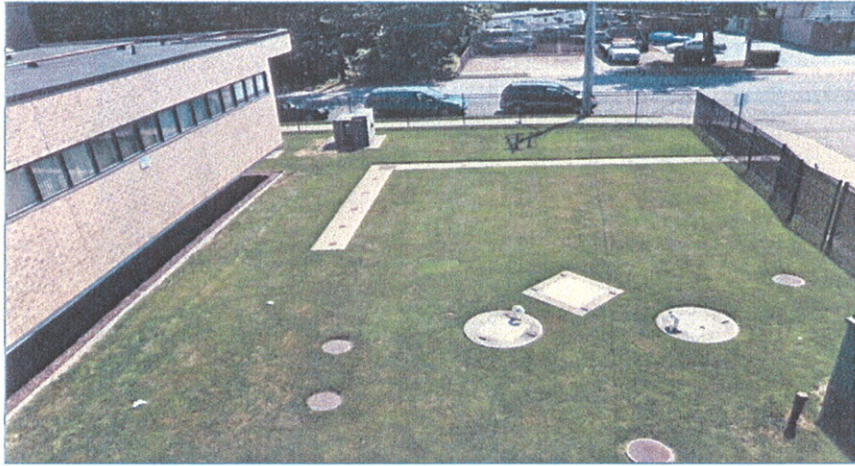
A DENITRIFICATION SYSTEM WAS ORIGINALLY INSTALLED IN THE MID NINETIES TO TREAT THE SANITARY WASTE FROM THE BUILDING PRIOR TO IT BEING DISCHARGED INTO THE GROUND. THIS IS LOCATED IN THE GRASSY AREA AT THE SOUTHEAST CORNER OF THE BUILDING.

BASED ON CONVERSATIONS WITH MAINTENANCE PERSONNEL AND GENERAL INFORMATION ABOUT THESE SYSTEMS, IT DOES NOT APPEAR THAT IT IS OPERATING CORRECTLY. THE RESULT IS THE DISCHARGE OF AN EXCESS OF NITRATES IN TO THE GROUND AND EVENTUALLY THE WATER TABLE.

THESE SYSTEMS ARE NO LONGER APPROVED BY THE SUFFOLK COUNTY HEALTH DEPARTMENT WHO WOULD PROBABLY REQUIRE THE INSTALLATION OF A SEWAGE TREATMENT PLANT, IF ANY EXPANSION WAS PLANNED FOR THE FACILITY.

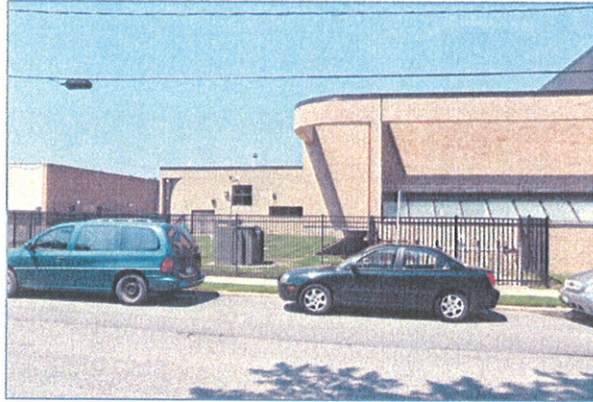
THE EXIT DOOR AT THE NORTH EAST CORNER OF 1995 SECTION IS SUBJECT TO OCCASIONAL FLOODING WHEN THE STORM SEWER NEAR THE DOOR BACKS UP IN PERIODS OF HEAVY RAIN.

THIS IS CAUSED BY THE RELATIVELY SMALL DIFFERENCE IN ELEVATION BETWEEN THE FINISHED FLOOR OF THE BUILDING AND THE ADJACENT STREET. EXCLUDING CHANGES TO THE STORM SEWER SYSTEM, OR CLOSING OFF THE DOORWAY (PROBABLY NOT A VIABLE OPTION), THERE DOES NOT APPEAR TO BE A SOLUTION TO THIS PROBLEM.

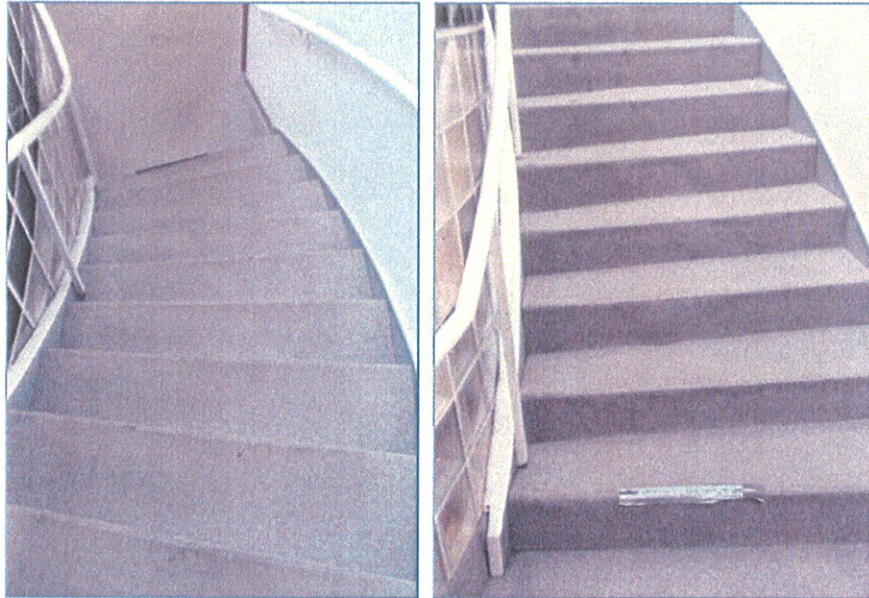
CARPET IS BADLY WORN AND SOILED

THIS IS THE MOST PREDOMINANT FLOORING MATERIAL AND IS BADLY WORN AND STAINED IN MANY AREAS. TWO CONSIDERATIONS FOR THE NEXT REPLACEMENT SHOULD BE THE SUBSTITUTION OF VINYL OR RUBBER TREADS ON THE STAIRS WHICH ARE ALWAYS SUBJECT TO EXCESSIVE WEAR AND THE USE OF CARPET TILES IN LIEU OF BROADLOOM MATERIAL. THIS TYPE OF MATERIAL IS USED IN MANY NEW PUBLIC AREAS BECAUSE IT ALLOWS STAINED AREAS TO BE SELECTIVELY AND EASILY REMOVED AND REPLACED WITHOUT INSTALLING NEW CARPET IN AN ENTIRE AREA.

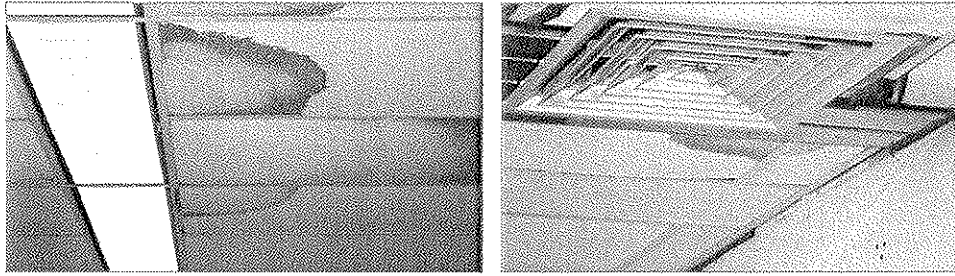
CELLAR CEILINGS ARE PRIMARILY UNPAINTED DRYWALL. ALL OTHER CEILINGS CONSIST OF DIFFERENT TYPES OF SUSPENDED CEILINGS. MANY AREAS SHOW EVIDENCE OF PAST WATER DAMAGE.

IT IS OUR UNDERSTANDING THAT ALMOST ALL OF THESE LEAKS HAVE BEEN ELIMINATED BY THE FALL 2009 ROOFING WORK (SEE ROOFING SECTION).

AS PER JANITORIAL STAFF, THE ONLY OCCASIONAL ROOF LEAKS OCCUR DURING A WIND DRIVEN RAIN, WHEN WATER INFILTRATION OCCURS IN THE VICINITY OF THE ROOF MOUNTED HVAC EQUIPMENT.

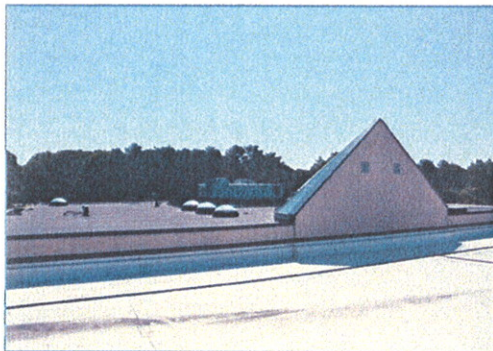
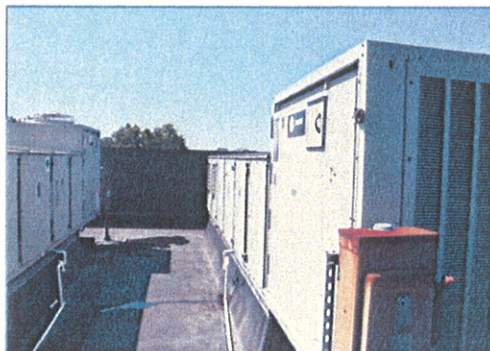
OIL FIRED STEAM HEATING PLANT ANTIQUATED AND INEFFICIENT  
TWENTY FIVE YEAR OLD ROOF TOP A/C UNITS (1995 SECTION)  
NEARING THE END OF THEIR LIFE CYCLE

**COOLING IS PROVIDED BY TWO ROOF TOP UNITS WHICH APPEAR TO BE ORIGINAL EQUIPMENT.**

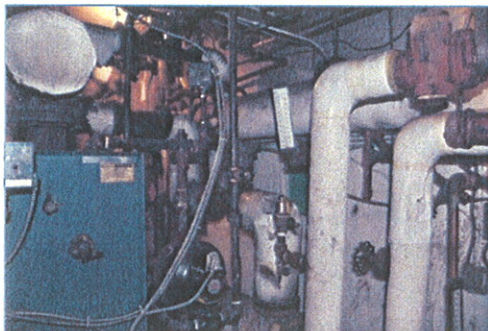
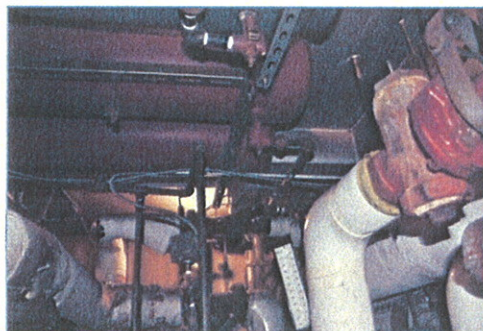
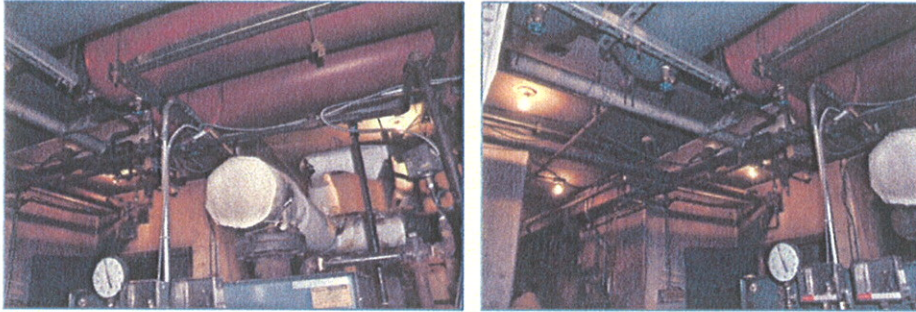
**HEATING IS PROVIDED BY AN OIL FIRED STEAM BOILER IN THE GELLAR OF THE 1995 BUILDING.**

BECAUSE OF BOTH THE BOILER'S AGE AND THE INEFFICIENCY CREATED BY USING STEAM TO HEAT WATER, THE BOILER SHOULD BE CONSIDERED FOR REPLACEMENT WITH ROOF TOP UNITS SIMILAR TO THOSE IN SERVICE ON THE 1982 SECTION.

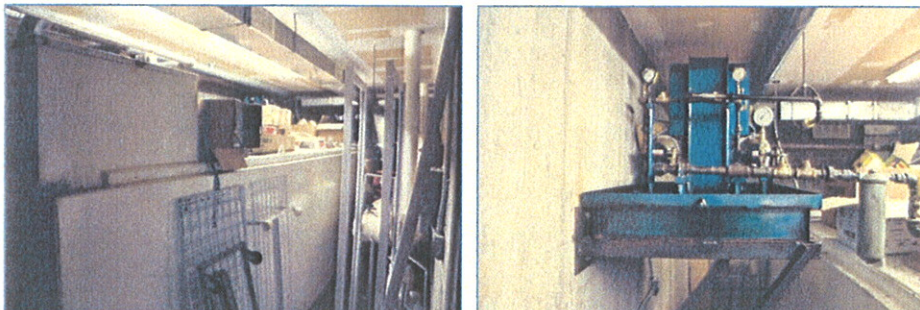
THERE IS A 3,000 GALLON OIL STORAGE TANK IN THE CELLAR OF THE 1995 SECTION WITH A TRANSFER PUMP TO SUPPLY OIL TO THE BOILER.

IN ADDITION TO THE INCREASED EFFICIENCY, THIS WOULD ELIMINATE THE NEED FOR THE LARGE OIL TANK. TOGETHER WITH THE REMOVAL OF THE BOILER, THIS WOULD FREE UP VALUABLE SPACE IN TWO AREAS OF THE CELLAR.

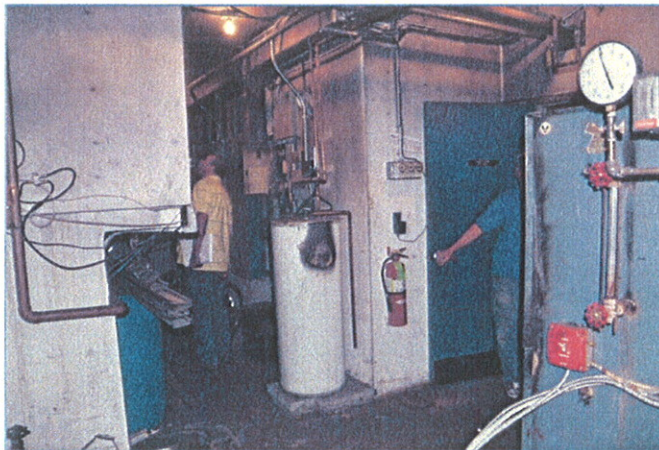
ALTHOUGH DOMESTIC HOT WATER IS CURRENTLY PROVIDED BY AN ELECTRIC WATER HEATER IN THE BOILER ROOM,

IT WOULD BE MORE EFFICIENT TO REPLACE THIS WITH A HIGH EFFICIENCY GAS FIRED UNIT.

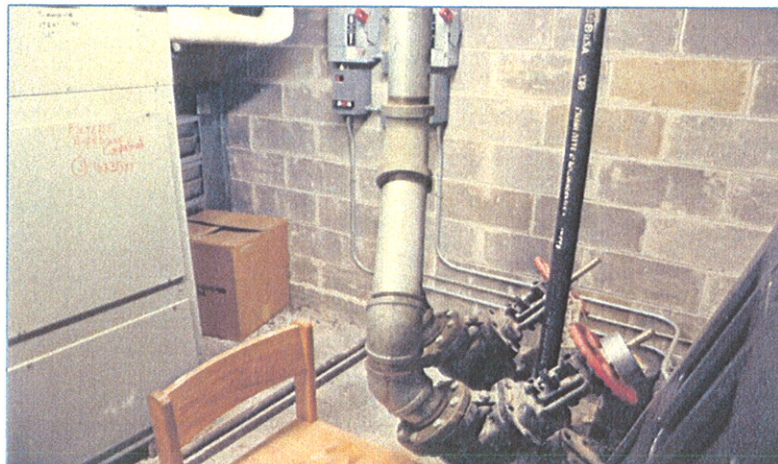
SEWAGE EJECTION PUMP SYSTEM NEEDS REPAIRS  
DOMESTIC WATER HEATER NEEDS REPLACEMENT

A TWIN PUMP SEWAGE EJECTION PUMP SYSTEM IN THE CELLAR OF THE 1995 SECTION COLLECTS ALL WASTE FLOW FROM THE BUILDING AND PUMPS IT TO THE DENITRIFICATION SYSTEM. WHILE BOTH PUMPS ARE OPERATIONAL, IT APPEARS THAT ONE FLOAT SWITCH IS NOT AND SHOULD BE REPAIRED/REPLACED. THE ROOM CONTAINING THESE PUMPS WAS OVERRUN WITH SMALL FLIES WHICH WE WERE TOLD HAVE RESISTED NUMEROUS EXTERMINATION ATTEMPTS.

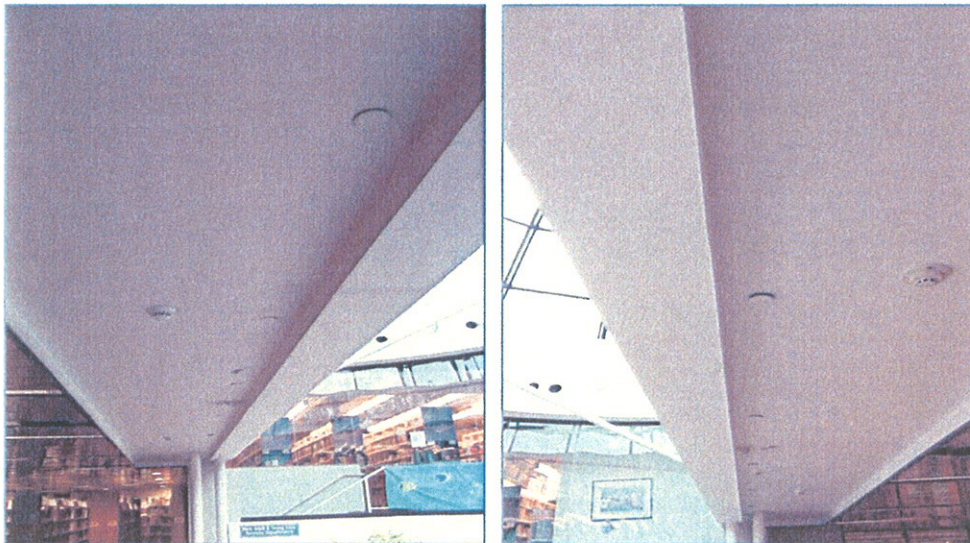
THE DELUGE HEADS SEPARATING THE OLD AND NEW SECTION  
NEEDS TO BE RECOMMISSIONED

THE ENTIRE BUILDING IS NOT PROTECTED BY THE SYSTEM. APPROXIMATELY 15 SPRINKLER HEADS ARE LOCATED BETWEEN THE OLD AND NEW SECTIONS OF THE LIBRARY ON THE MAIN FLOOR.

NO INFORMATION WAS AVAILABLE AS TO WHY THIS SYSTEM DOES NOT UNDERGO ANNUAL TESTING.

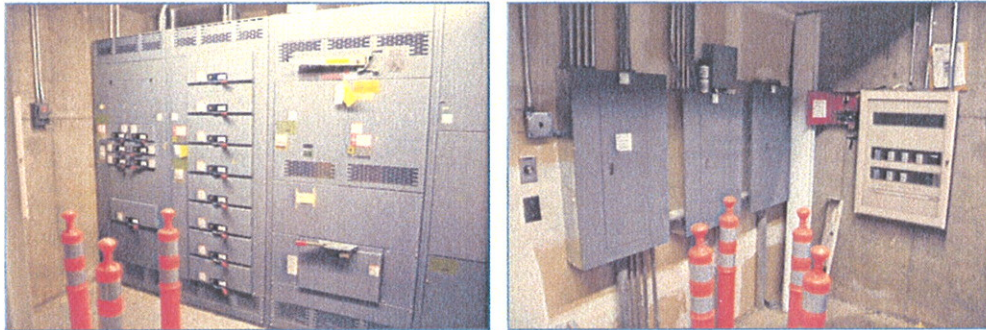
PEAK SUMMER ELECTRICAL LOAD LEVELS EXCEED RATED CAPACITY  
OF THE ELECTRICAL SERVICE IN BOTH 2008 AND 2009

THE MAIN ELECTRICAL SERVICE IS A 120/208 3 PHASE WYE CONFIGURATION

THE MAIN DISCONNECT SWITCH IS 1600 AMP AND WITH 80% SAFETY FACTOR, THIS EQUALS APPROXIMATELY 1280 AMPS

THE CURRENT CONSUMPTION IS AT THE APPROXIMATE SAFE MAXIMUM OF THE SERVICE, AND ANY ADDITIONS TO THE LOAD WOULD REQUIRE A NEW SERVICE.
