# MASTIC MORICHES SHIRLEY COMMUNITY LIBRARY

## BUILDING CONDITION REVIEW REPORT

JULY 2, 2010

SANDPEBBLE BUILDERS INC.  
921 COUNTY ROAD 39  
SOUTHAMPTON, NY 11968  
631-287-6000

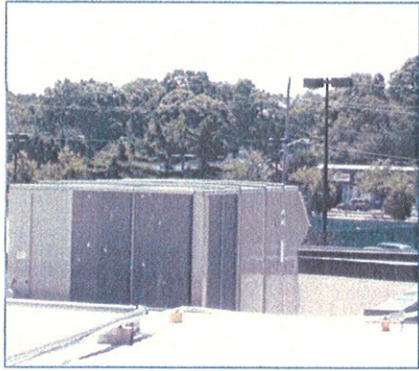
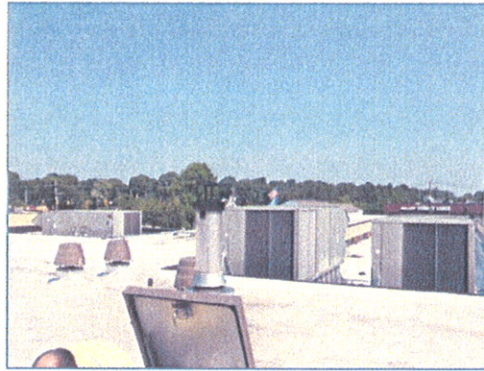
HEATING AND COOLING ARE PROVIDED BY THREE ROOF TOP UNITS POWERED BY NATURAL GAS AND ELECTRICITY. AS PER PAT McCOMB AT THERMAL SOLUTIONS, ONE UNIT IS APPROXIMATELY SEVEN YEARS OLD AND THE OTHER TWO WERE REPLACED ABOUT FIVE YEARS AGO.

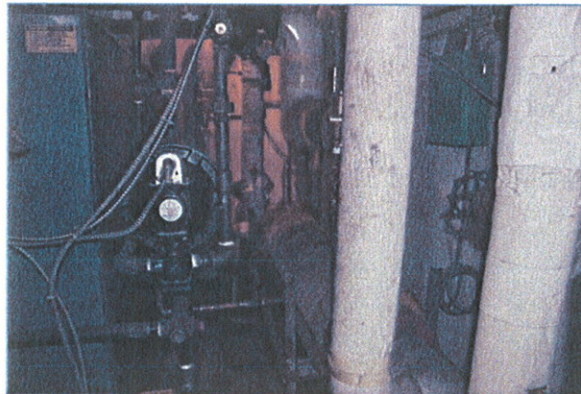
IN A HEAT EXCHANGER, THE STEAM IS USED TO PRODUCE HOT WATER WHICH IS THEN CIRCULATED THROUGH THE BUILDING TO PRODUCE HEAT.

THERE IS A 3,000 GALLON OIL STORAGE TANK IN THE CELLAR OF THE 1995 SECTION WITH A TRANSFER PUMP TO SUPPLY OIL TO THE BOILER.

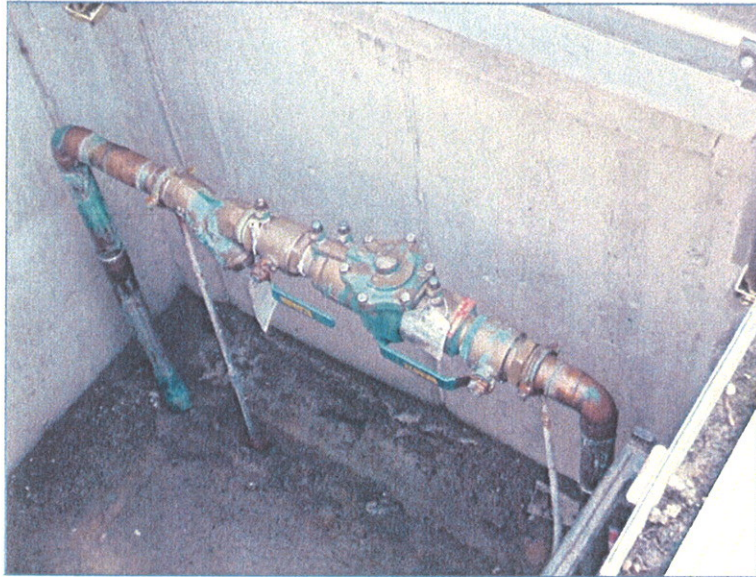
DOMESTIC WATER IS PROVIDED BY A 2" SERVICE WITH AN RPZ VALVE LOCATED IN A PIT ON THE NORTH SIDE OF THE BUILDING. THE WATER SYSTEM SEEMS ADEQUATE.

WHILE THE BATHROOMS APPEAR TO FUNCTION ACCEPTABLY, THEY APPEAR TO BE SUBJECT TO EXCESSIVE WEAR AND TEAR AND THE RESULTANT CONTINUAL MAINTENANCE.

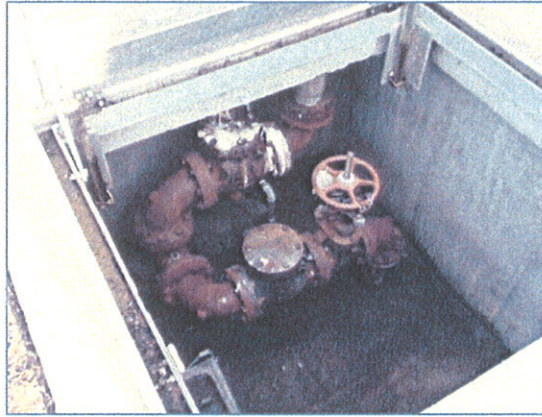
THE WATER SUPPLY FOR THE FIRE PROTECTION SYSTEM CONSISTS OF A 4" SERVICE BEGINNING IN A PIT ON THE NORTH SIDE OF THE BUILDING. THIS IS REDUCED TO 2 1/2" ONCE IT ENTERS THE BUILDING.

THE ENTIRE BUILDING IS NOT PROTECTED BY THE SYSTEM. APPROXIMATELY 15 SPRINKLER HEADS ARE LOCATED BETWEEN THE OLD AND NEW SECTIONS OF THE LIBRARY ON THE MAIN FLOOR.
