Re: Site Visit at
407 William Floyd Pkwy, Shirley, NY

TDM Consulting Engineer, P.C. has recently performed a site visit at the Mastic-Moriches-Shirley Library project located at 407 William Floyd Pkwy, Shirley, NY. There were several items that we investigated while on the site that will require remediation or further investigation. These items are as follows:

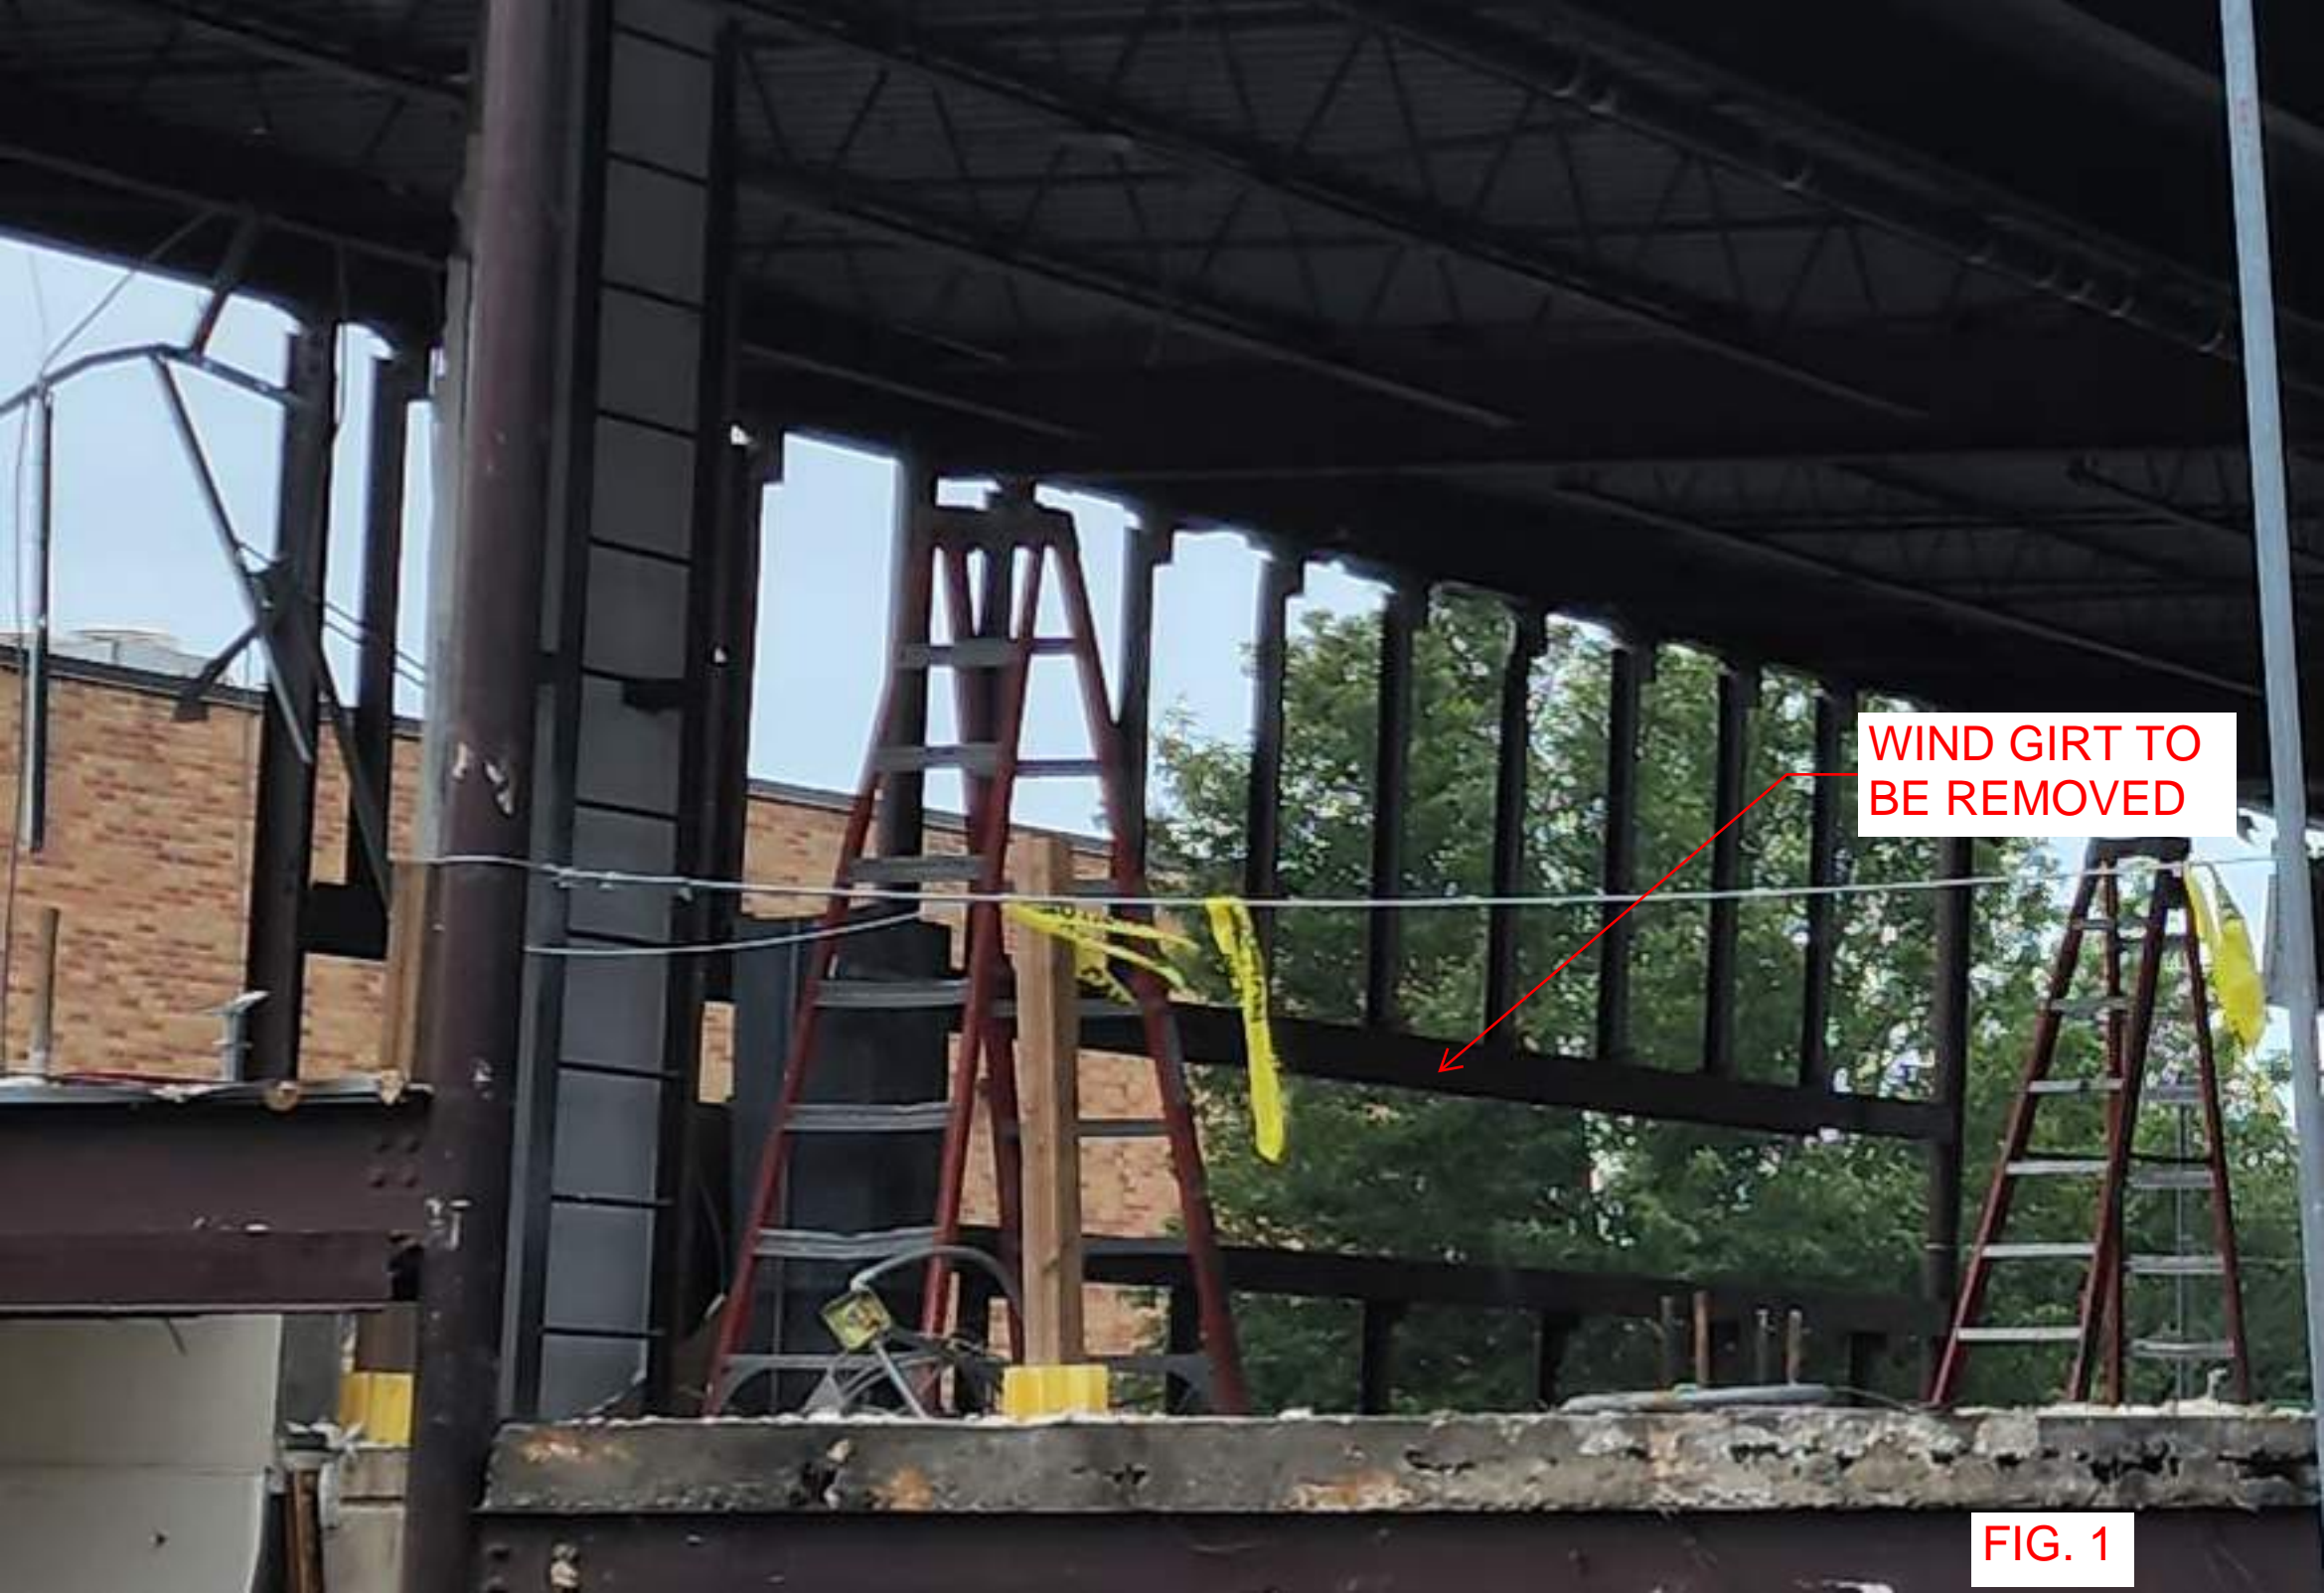
FIG. 1

WIND GIRTS TO BE REMOVED

- Removal of intermediate steel wind girts along column line 1. See Fig. 1.
- Possible addition of column(s) at front entrance, waiting on architectural review of details for confirmation. See Fig. 2.
